**Town of Brighton, Vermont**

**Request for Proposal**

**Heat Pump Installation for Railroad Depot Building**

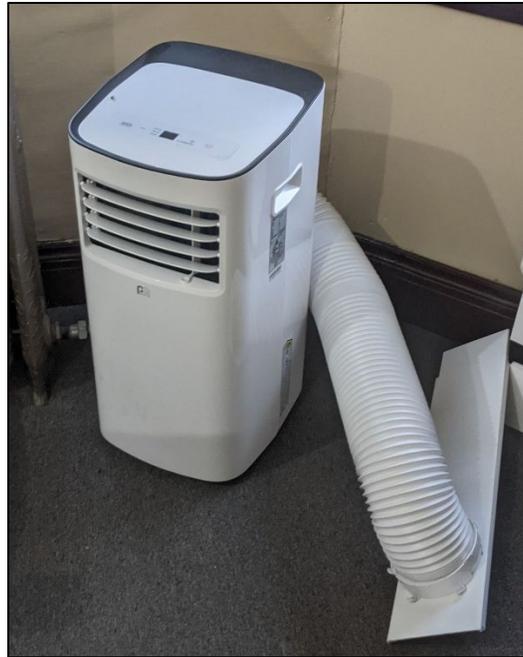
Figure 4: Portable air conditioning unit

Three portable air conditioning units were observed on the second floor during the site visit (Figure 4). Two units are 10 MBh units from 2021 with a CEER of 6.9. One unit is a 14 MBh unit with a CEER of 12.9.

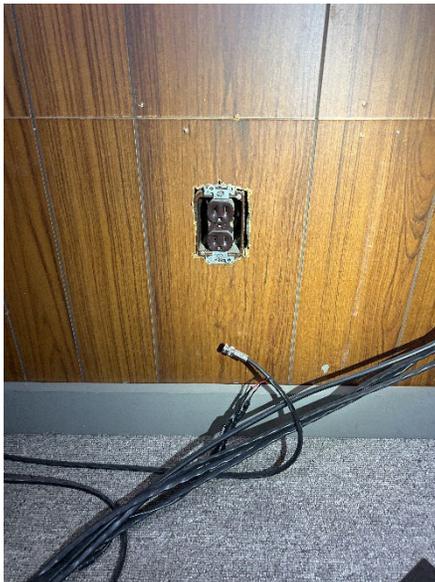
The largest issue identified during this assessment was the lack of insulation present at the exterior wall assemblies. These wall assemblies are primarily brick masonry on the exterior with wood stud framing/strapping to support drywall or wood paneling on the interior, with air spaces of various depths. No insulation was found at any location within the exterior wall assembly. Without performing more destructing sampling it was difficult to determine the exact depth of framing and air spaces between the interior finish and the back of brick masonry, but this was typically approximately 3".

*A typical outlet on an exterior wall on the 2<sup>nd</sup> floor.*

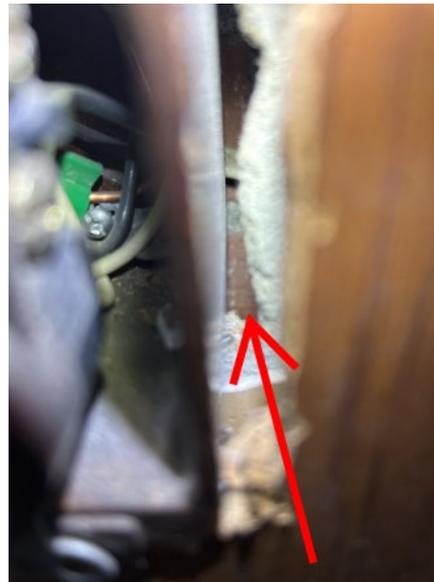
*Looking around this outlet the back of brick is visible, no insulation is present.*

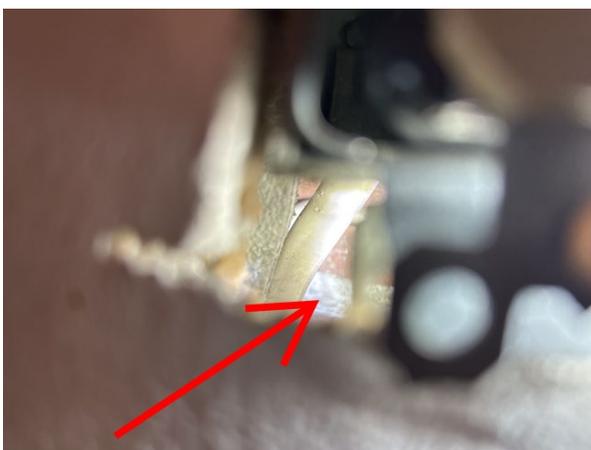
*Looking behind another outlet on an exterior wall, similar findings with the back of brick visible.*

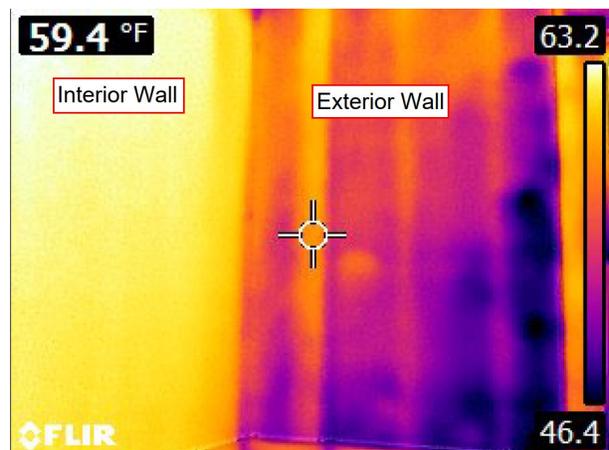
*An example of a location where an exterior wall meets an interior wall, the exterior wall is visibly much cooler.*

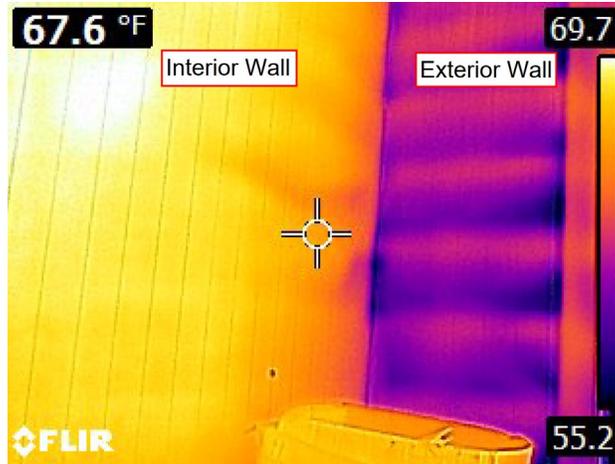
*Another example of an exterior wall compared to an interior wall.*

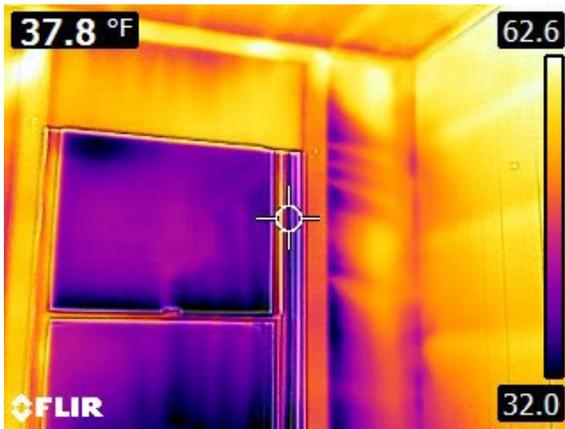
Overall, the windows of this building were not performing well with significant air leakage visible, and poor insulating R-value. Single pane glass has an R-value of approximately 0.9 and the aluminum frames have a high thermal conductivity compared to other window framing materials such as wood, vinyl, or fiberglass which contributes to the heat loss. Exterior storms improve the R-value by adding an additional pane of glass and an insulated air space, however this improved R-value is dependent on a tightly fitting storm window. If the storm window is left open or if it is poorly sealed, cold exterior air is able to bypass it and virtually eliminate its effectiveness. Several of the storm windows on the 2<sup>nd</sup> floor were found to be open, and many of the aluminum framed storms & windows were found to be very leaky. A mix of results was found at the first-floor windows. Some units were found to have significant air leakage while others performed relatively well. The performance of each unit appeared to be connected to the condition of the gasketing of the exterior storm windows. Those with continuous gasketing that was well compressed performed much better than those with damaged or poorly fitted gasketing. The window rough openings also appeared to be very leaky, as cold air could be seen consistently entering around the wood trim.

*Air leakage visible around the wooden trim at the window jamb.*

The air leakage around the rough openings of the windows can be improved by removing the interior trim and applying low-expanding canned spray foam around the perimeter. If installed continuously without voids this foam will drastically reduce the air leakage around the rough opening and provide some improved R-value. If the wood trim is removed without major damage, it can also be re-installed without replacement trim needed.

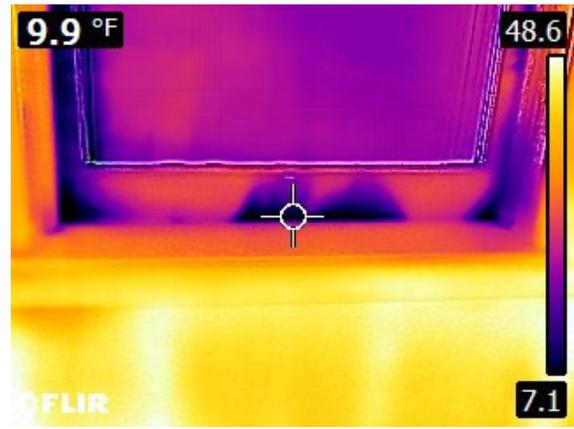
*Air leakage under a window sill, the air entering is ~10 degrees.*

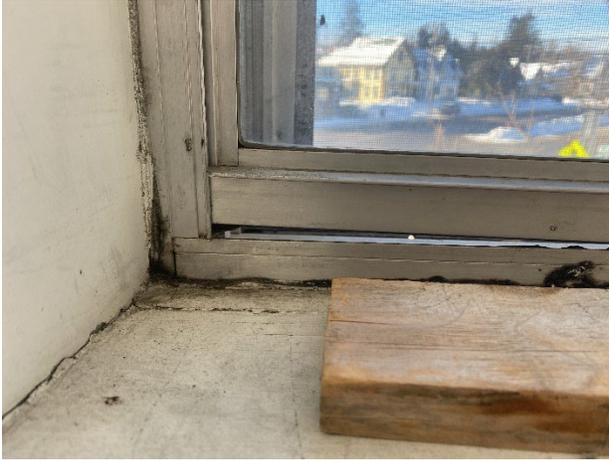
Many of the windows were also in poor condition regarding operability, as some of the hardware was missing on the wood frame windows and the ropes for the weighted systems were cut. Since the storm windows on the first floor are sealed in place, the windows are assumed to be no longer operable.

*An example of an aluminum framed window that is unable to close fully. This was found in several locations.*

The windows at the 2<sup>nd</sup> floor (both wood framed and aluminum framed) performed much worse and would benefit from some modifications. Again, a full replacement is likely not a cost-effective solution especially given the relatively low use the upstairs portion of the building appears to receive. At these 2<sup>nd</sup> floor windows, Cx Associates would recommend someone is hired to perform basic repairs as needed to ensure all windows are able to fully close, and broken glass is replaced. In addition to this, interior window inserts could be installed to reduce the air leakage around the window unit and improve the R-value. This window insert would be very similar to the exterior storms present at the first floor. They can be framed with wood, fiberglass, acrylic, or other materials, are typically a single pane of glass, and have foam/rubber gasketing around the perimeter. They can be custom sized and installed around the interior trim of the existing window openings without any major demolition. While in place they will prevent the windows from being operable, but they are also removable if they are not desired in the warmer months. At pricing of around \$35/square foot, they are much more affordable than a full replacement.

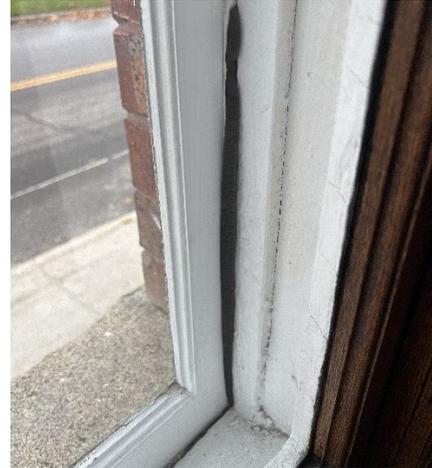
*An example of foam gasketing present at the wood storms on the first floor. This helps provide a much tighter seal than what was found at the aluminum storms.*

Full window replacements are typically extremely costly and result in very long payback periods, preventing them from being a cost-effective solution. Given the performance of the wood framed windows on the 1<sup>st</sup> floor and the condition of their exterior storms, replacement at these locations is not recommended at this time. However, Cx Associates would recommend improving the gasketing at the exterior storms where damage or voids are present.

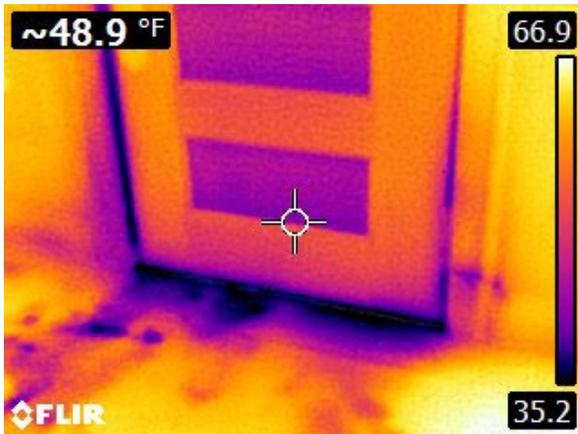
Several exterior doors are present on the 1<sup>st</sup> floor of this building, most of which were poorly sealed and allowed air leakage as shown in the photos below. In some instances weather stripping such as brush seals were present, however they were loose and did not create a tight seal. The majority of the leakage appeared to be around door thresholds where no door bottoms or sweeps were present.

*An example of air leakage at the threshold of the bank entry door.*

To reduce the air leakage around these exterior doors Cx Associates recommends installing or replacing weather stripping around the perimeter. Where they are missing, door bottoms should be installed to establish a tight seal between the door and threshold. Neoprene, rubber, or foam gasketing around the head and jambs will also reduce the air leakage. After this weatherstripping is installed, doors should be adjusted as needed to ensure they fit tightly against the gasketing when closed.

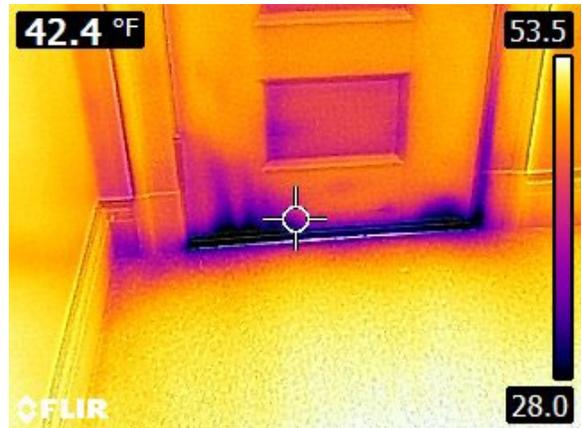
*Another example of air leakage around the threshold of an exterior door.*

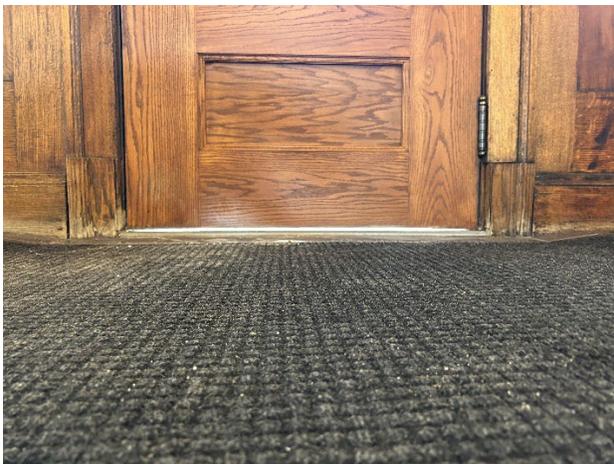
*Daylight is visible at the bottom of several exterior doors.*

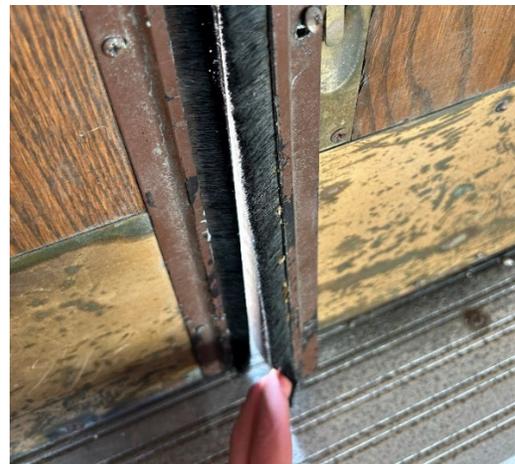
*Weatherstripping is in place at the ATM vestibule doors, but do not provide a tight seal.*

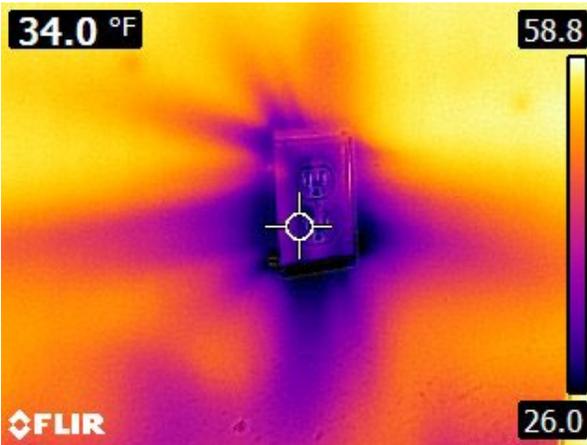
Without a dedicated air barrier layer in the exterior wall assembly, the interior finish materials such as drywall and wood paneling act as this barrier. Electrical boxes such as outlets and switches were the most common penetrations in the exterior wall, and they consistently showed significant air infiltration. As shown in the photos below, the air entering around outlets was typically around 30 degrees colder than the surrounding surfaces.

*An example of an outlet on and exterior wall with air leakage visible.*

Air leakage at these switches and outlets could be reduced by removing the cover plates and caulking the perimeter of the outlets to the drywall/wood paneling, eliminating the gap around the boxes. Another option would be to install foam pads behind the cover plates to create a better seal. Some air leakage will likely be present through the box itself where wire penetrations are present, but this cannot be improved without removing finishes to expose the back of these boxes.

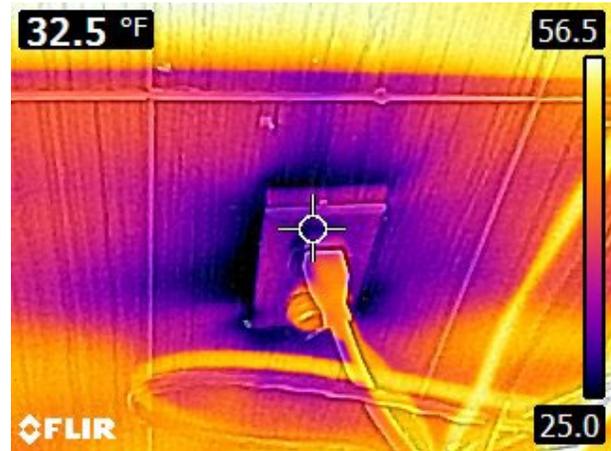
*Another example of an outlet with cold air leakage.*

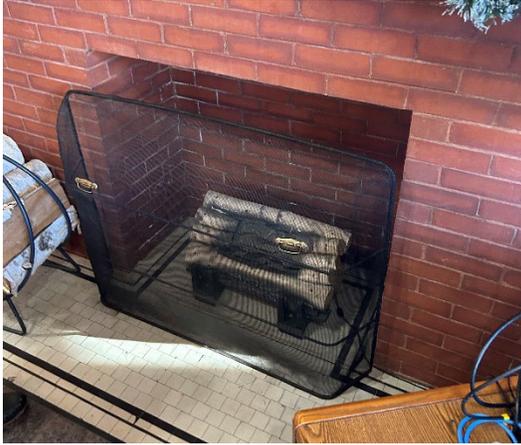
The fireplace located at the first floor bank was found to have cold air infiltration around the damper/connection to the chimney. This fireplace is no longer in use and the damper has been stuffed with fiberglass insulation. While this fiberglass provides some R-value, it does not provide an air seal and still allows heat to escape or cold air to enter.

*A view of the fireplace in the bank, it is no longer in use and only for aesthetics.*

Since this fireplace is no longer in use, Cx Associates recommends installing a more permanent and airtight seal around the damper and chimney. Closed cell spray foam would be the best material for this, as it will seal the space and provide some R-value. If the damper is able to be removed to access the chimney, a small enclosure could be constructed in the shaft to create a backstop to support rigid foam insulation, with spray foam around the perimeter. As it is currently, spray foam could be added in the small gap to replace the fiberglass, but it could likely not cover the metal damper entirely without being visible from the interior and impacting aesthetics.

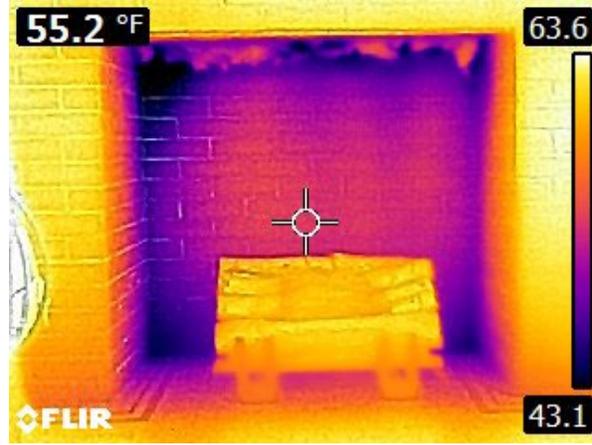
*IR imaging of the fireplace, the brick in this opening is much cooler than the surrounding areas.*

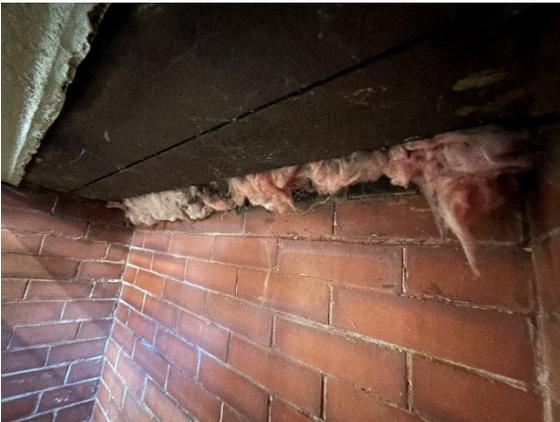
*Looking up into the chimney, some fiberglass is present but this is not creating an air-tight seal.*

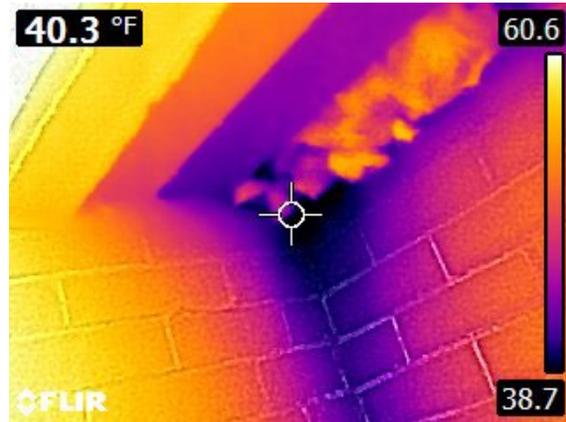
*IR imaging looking up into the chimney.*

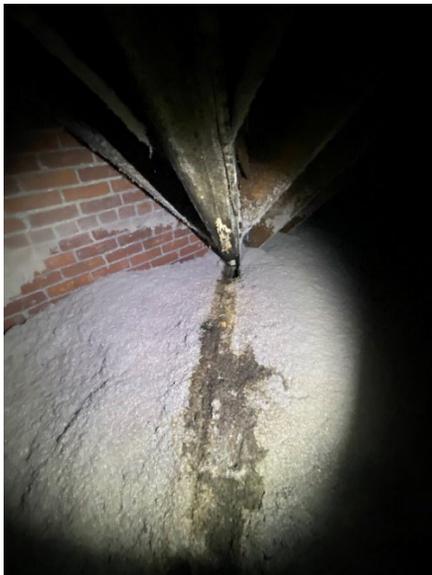
It is worth noting that the attic space is very well insulated, with approximately 16" of blown-in cellulose insulation resulting in an R-value of approximately 50. As shown in the photos below, there were some signs of water damage in the attic space in several locations. Water drops and staining could be seen on the cellulose insulation. It was unclear if this is the result of previous leaks that have since been repaired, or if these are active leaks. The roof was not available to safely inspect from the exterior during this assessment. Cx Associates recommends these locations are reviewed with maintenance staff to determine if they were known and previously repaired. Water infiltration will reduce the effectiveness of the insulation and eventually cause damage to the structure and interior finishes.

*An example location where water staining is visible on the insulation below a rafter.*

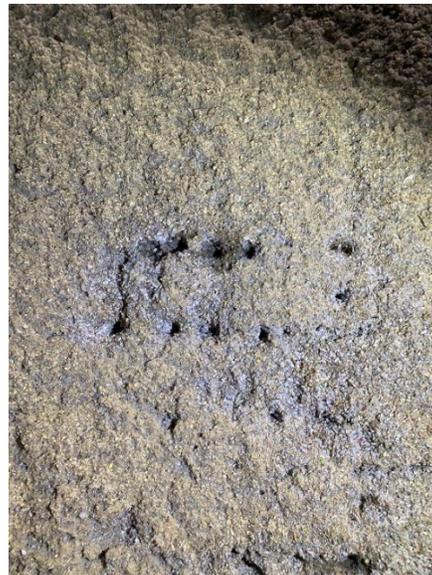
*Another location where there was evidence of water dripping into the insulation.*
