**Town of Brighton, Vermont**

**Request for Proposal**

**Heat Pump Installation for Railroad Depot Building**

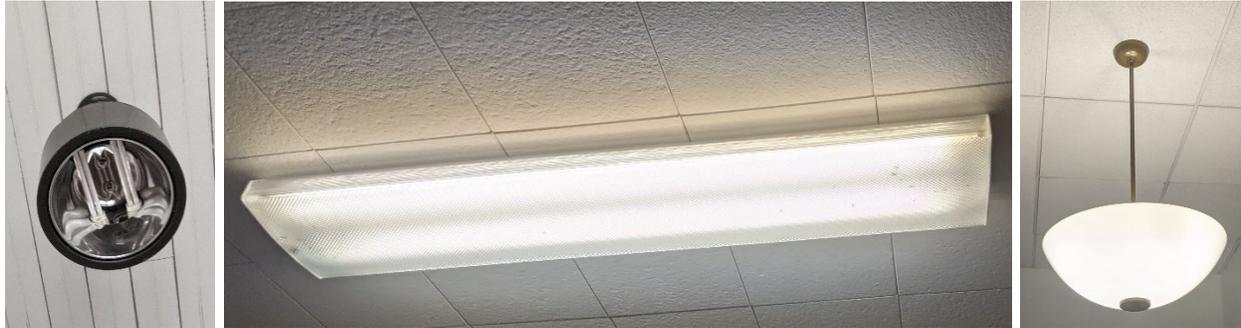
lighting is on switch controls (no occupancy or daylighting controls were observed during the site visit).

Figure 2: Examples of three different fixtures at the facility, from left to right, a suspended fixture with CFL bulbs, a surface mounted wraparound 48" T8 Fixture, and pendant fixture

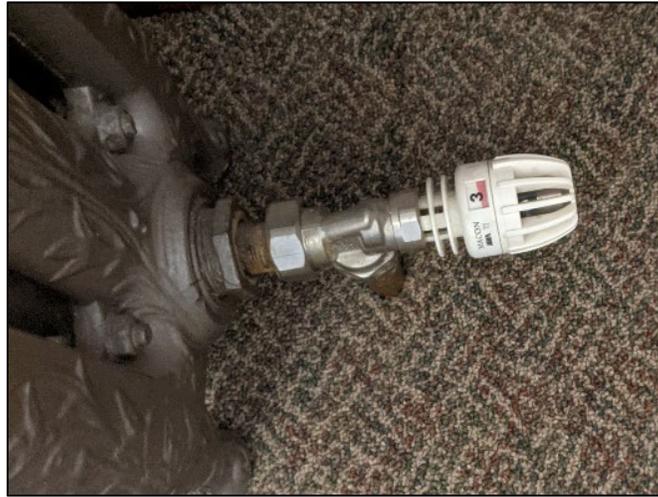
During the site visit the boiler was providing water at 170°F. Hot water is distributed to cast iron radiators in the building by two 1-hp pumps. These pumps are plumbed in a redundant configuration with one of them being powered off during the site visit. Heating is controlled manually by thermostatic radiator valves on each radiator (Figure 3).

Figure 3: A thermostatic radiator valve on a radiator

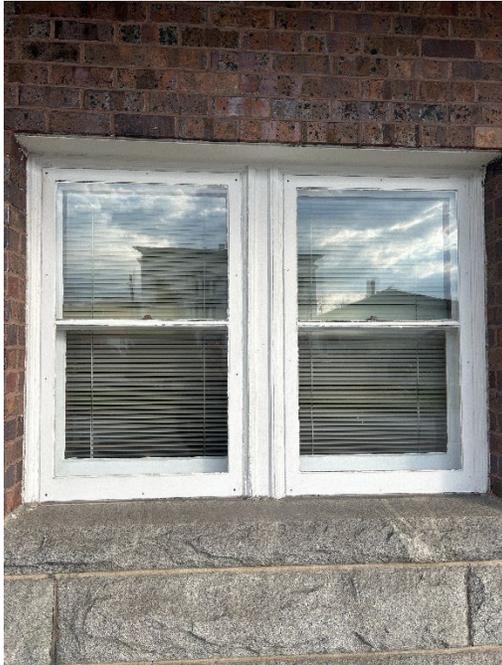
Many of the windows were also in poor condition regarding operability, as some of the hardware was missing on the wood frame windows and the ropes for the weighted systems were cut. Since the storm windows on the first floor are sealed in place, the windows are assumed to be no longer operable.

*An example of wood framed windows on the 1<sup>st</sup> floor with wood framed storms.*

Full window replacements are typically extremely costly and result in very long payback periods, preventing them from being a cost-effective solution. Given the performance of the wood framed windows on the 1<sup>st</sup> floor and the condition of their exterior storms, replacement at these locations is not recommended at this time. However, Cx Associates would recommend improving the gasketing at the exterior storms where damage or voids are present.

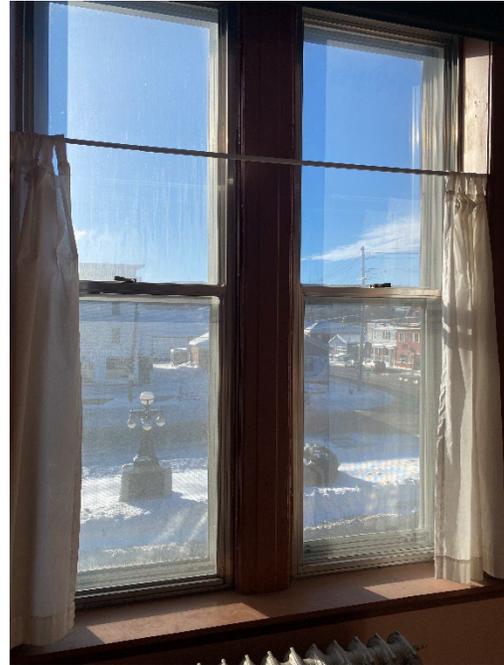
Overall, the windows of this building were not performing well with significant air leakage visible, and poor insulating R-value. Single pane glass has an R-value of approximately 0.9 and the aluminum frames have a high thermal conductivity compared to other window framing materials such as wood, vinyl, or fiberglass which contributes to the heat loss. Exterior storms improve the R-value by adding an additional pane of glass and an insulated air space, however this improved R-value is dependent on a tightly fitting storm window. If the storm window is left open or if it is poorly sealed, cold exterior air is able to bypass it and virtually eliminate its effectiveness. Several of the storm windows on the 2<sup>nd</sup> floor were found to be open, and many of the aluminum framed storms & windows were found to be very leaky. A mix of results was found at the first-floor windows. Some units were found to have significant air leakage while others performed relatively well. The performance of each unit appeared to be connected to the condition of the gasketing of the exterior storm windows. Those with continuous gasketing that was well compressed performed much better than those with damaged or poorly fitted gasketing. The window rough openings also appeared to be very leaky, as cold air could be seen consistently entering around the wood trim.

*Aluminum framed windows on the 2<sup>nd</sup> floor.*

The windows at the 2<sup>nd</sup> floor (both wood framed and aluminum framed) performed much worse and would benefit from some modifications. Again, a full replacement is likely not a cost-effective solution especially given the relatively low use the upstairs portion of the building appears to receive. At these 2<sup>nd</sup> floor windows, Cx Associates would recommend someone is hired to perform basic repairs as needed to ensure all windows are able to fully close, and broken glass is replaced. In addition to this, interior window inserts could be installed to reduce the air leakage around the window unit and improve the R-value. This window insert would be very similar to the exterior storms present at the first floor. They can be framed with wood, fiberglass, acrylic, or other materials, are typically a single pane of glass, and have foam/rubber gasketing around the perimeter. They can be custom sized and installed around the interior trim of the existing window openings without any major demolition. While in place they will prevent the windows from being operable, but they are also removable if they are not desired in the warmer months. At pricing of around \$35/square foot, they are much more affordable than a full replacement.

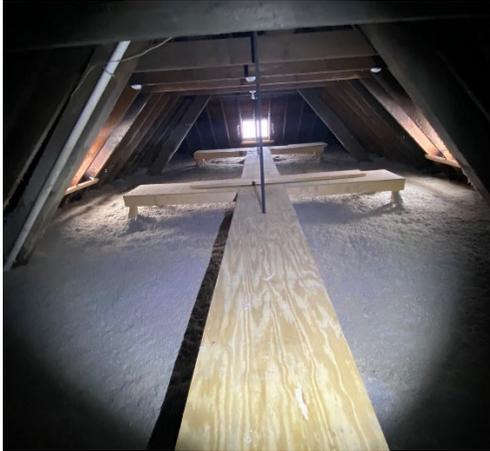
*A view of the attic with good insulation coverage.*

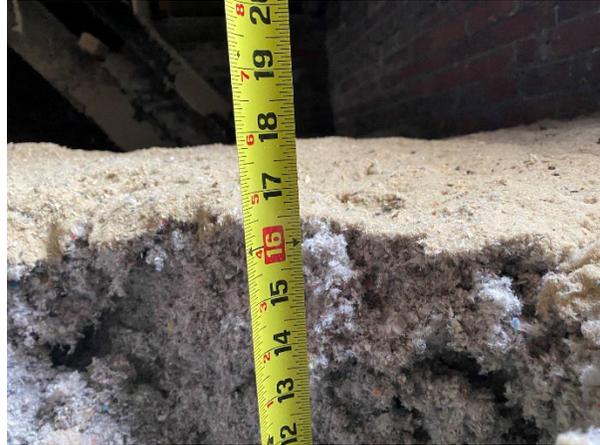
*Approximately 16" of blown-in cellulose insulation.*

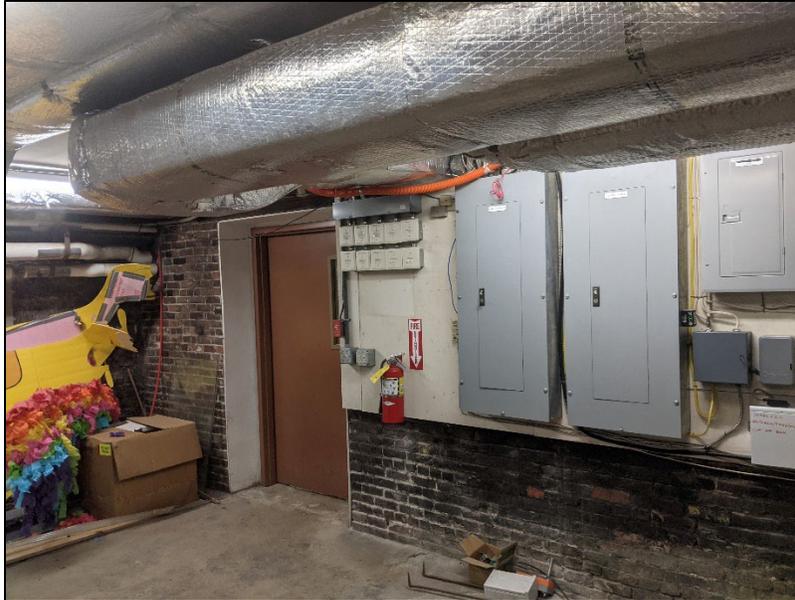
Figure 12: Electrical panels

There appears to be sufficient space in the basement to install a battery, but it may need to be placed on a different wall than the electric panels (Figure 13). A single lithium-ion battery has a capacity of around 14 kWh, which would be able to meet the facility's electricity needs for around a day during the summer and part of the shoulder seasons but less during winter<sup>8</sup>. Battery costs may amount to around \$1,200 per kWh, so an installation may cost around \$17,000.

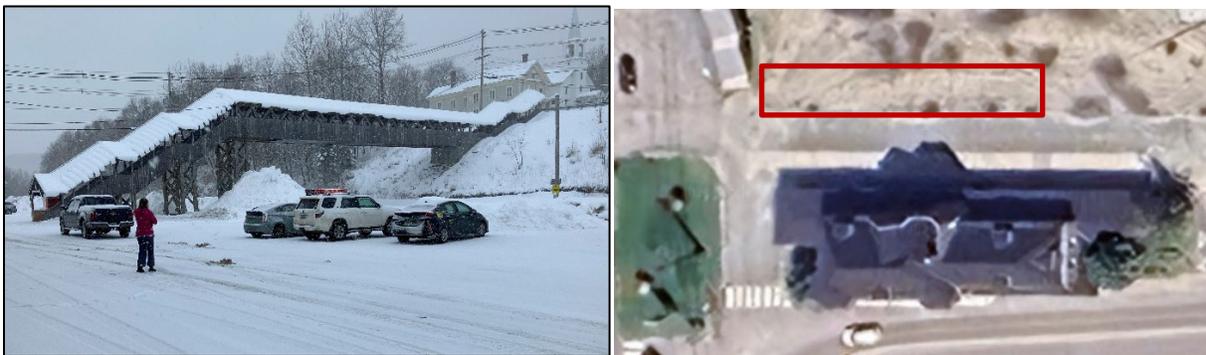
Figure 13: Potential area for EV chargers

As electric vehicles become more common, it will be useful to have electric vehicle charging stations located at buildings for staff and visitors. There are three types of chargers available (Level 1, 2, and 3) – Level 2 chargers would be most appropriate for the facility, which charge at 240V and can typically add 10-20 miles per hour of range to the battery. There appears to be room in at least two of the main electric panels to add circuits for EV chargers, which typically require 40-amp circuits for Level 2 chargers. There is also room in the parking lot for chargers (Figure 14). Level 2 chargers cost around \$800 for just the hardware, but total installation costs can be significantly higher as electrical service will need to be provided through a trench from the main panel to the charging area (\$5,000-10,000).
